BUREAU OF SHIPS GROUP TECHNICAL INSPECTION REPORT

⑥ OPERATION CROSSROADS.

U.S.S. STACK (DD 406)

TEST ABLE [U].

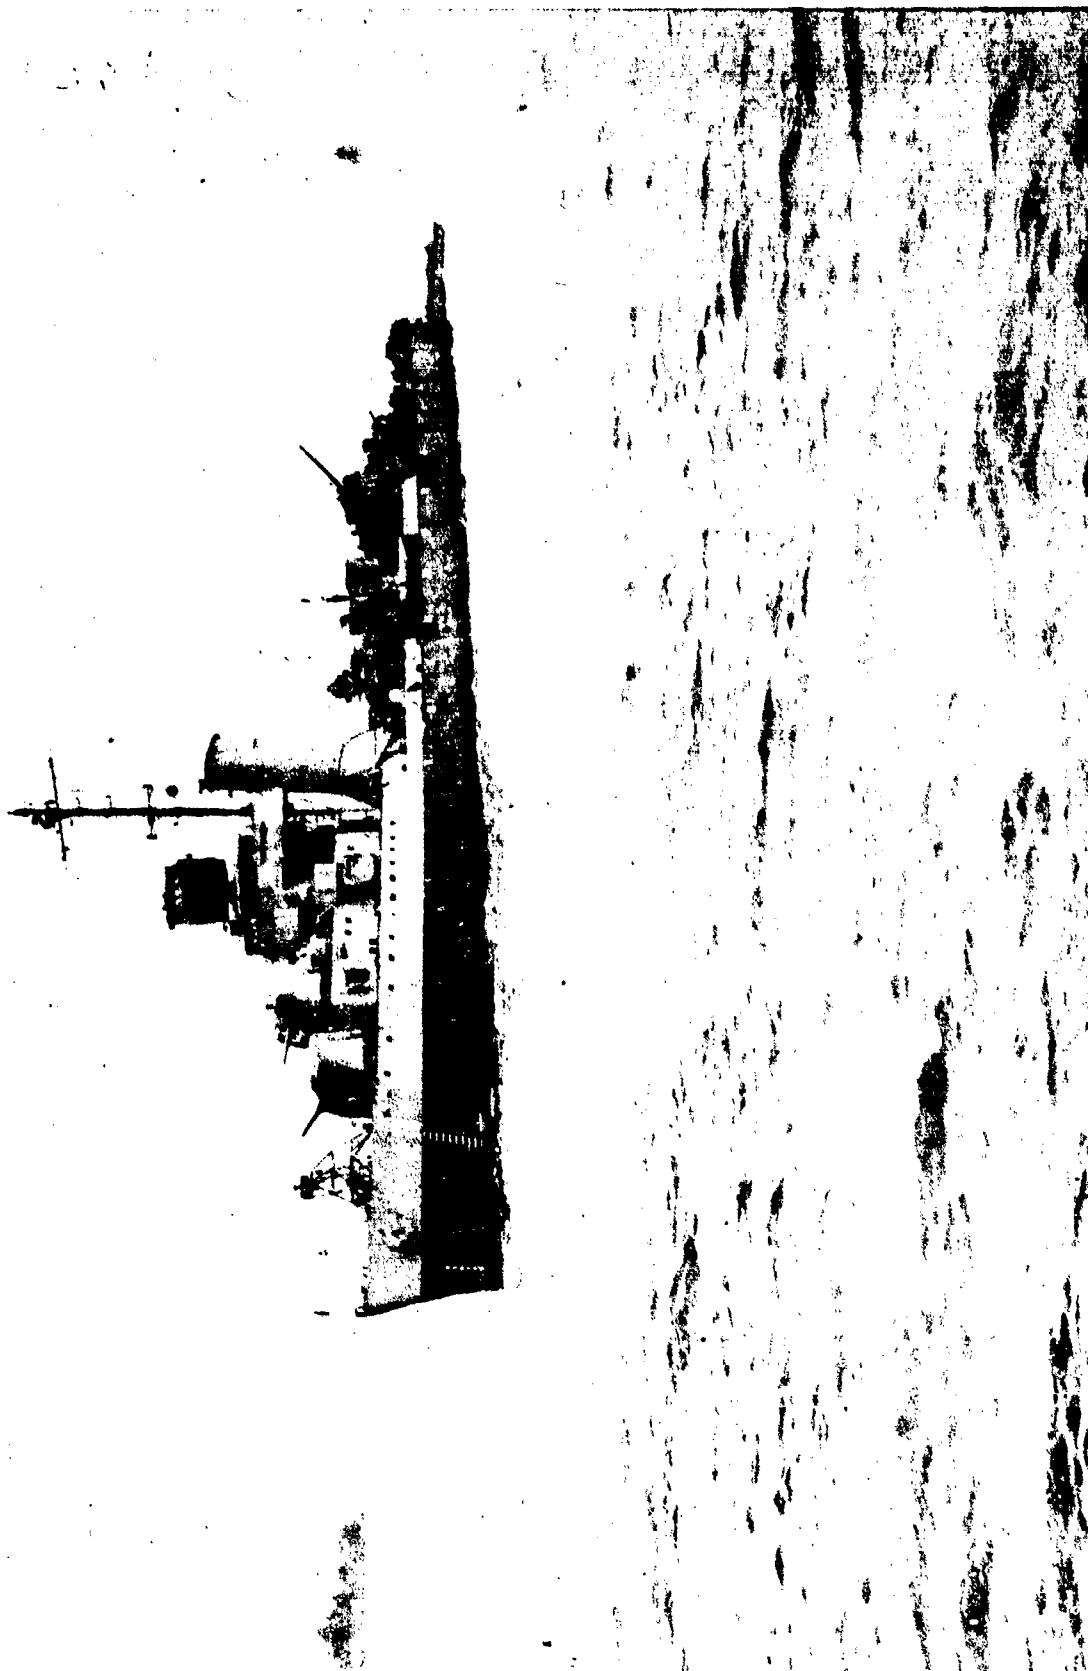
AA-CR-227-49-144. View from off port bow after Test A.

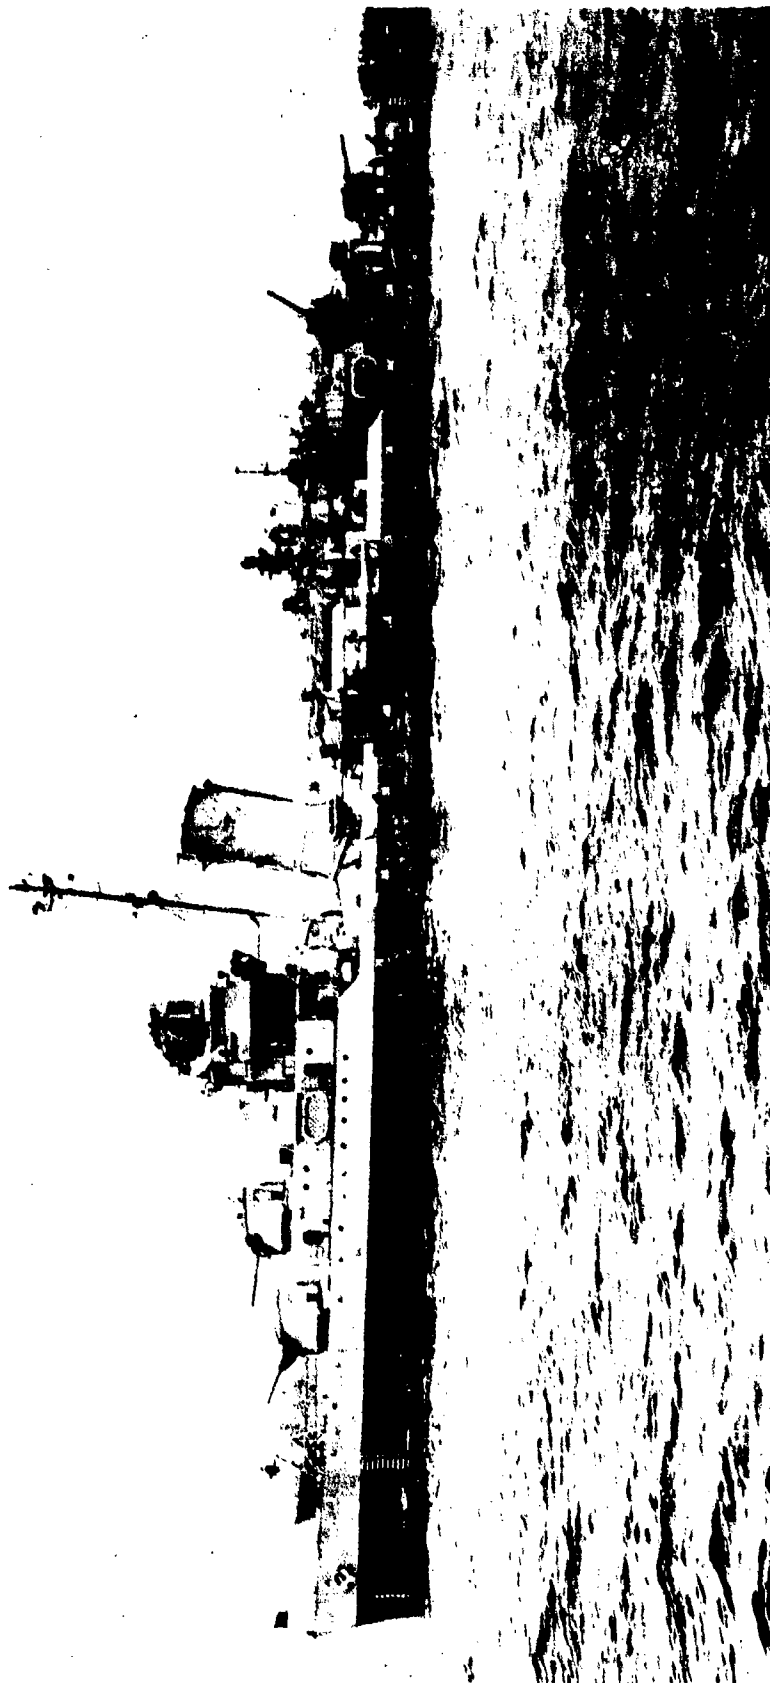
AA-CR-227-49-145. View from off port beam after Test A.

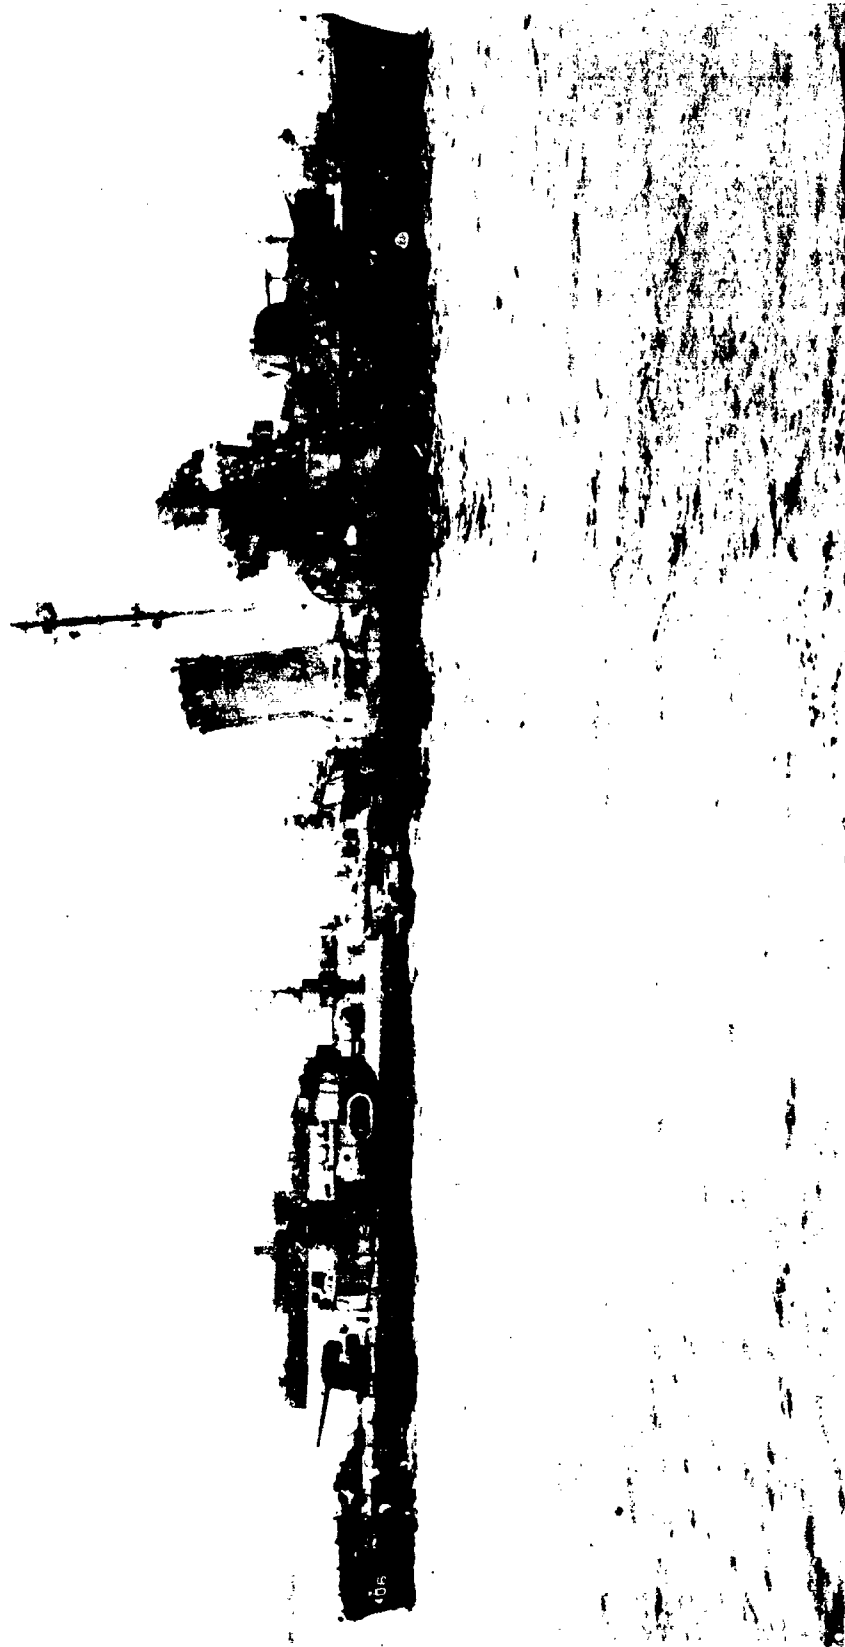
AA-CR-227-49-141. View from off port quarter after Test A.

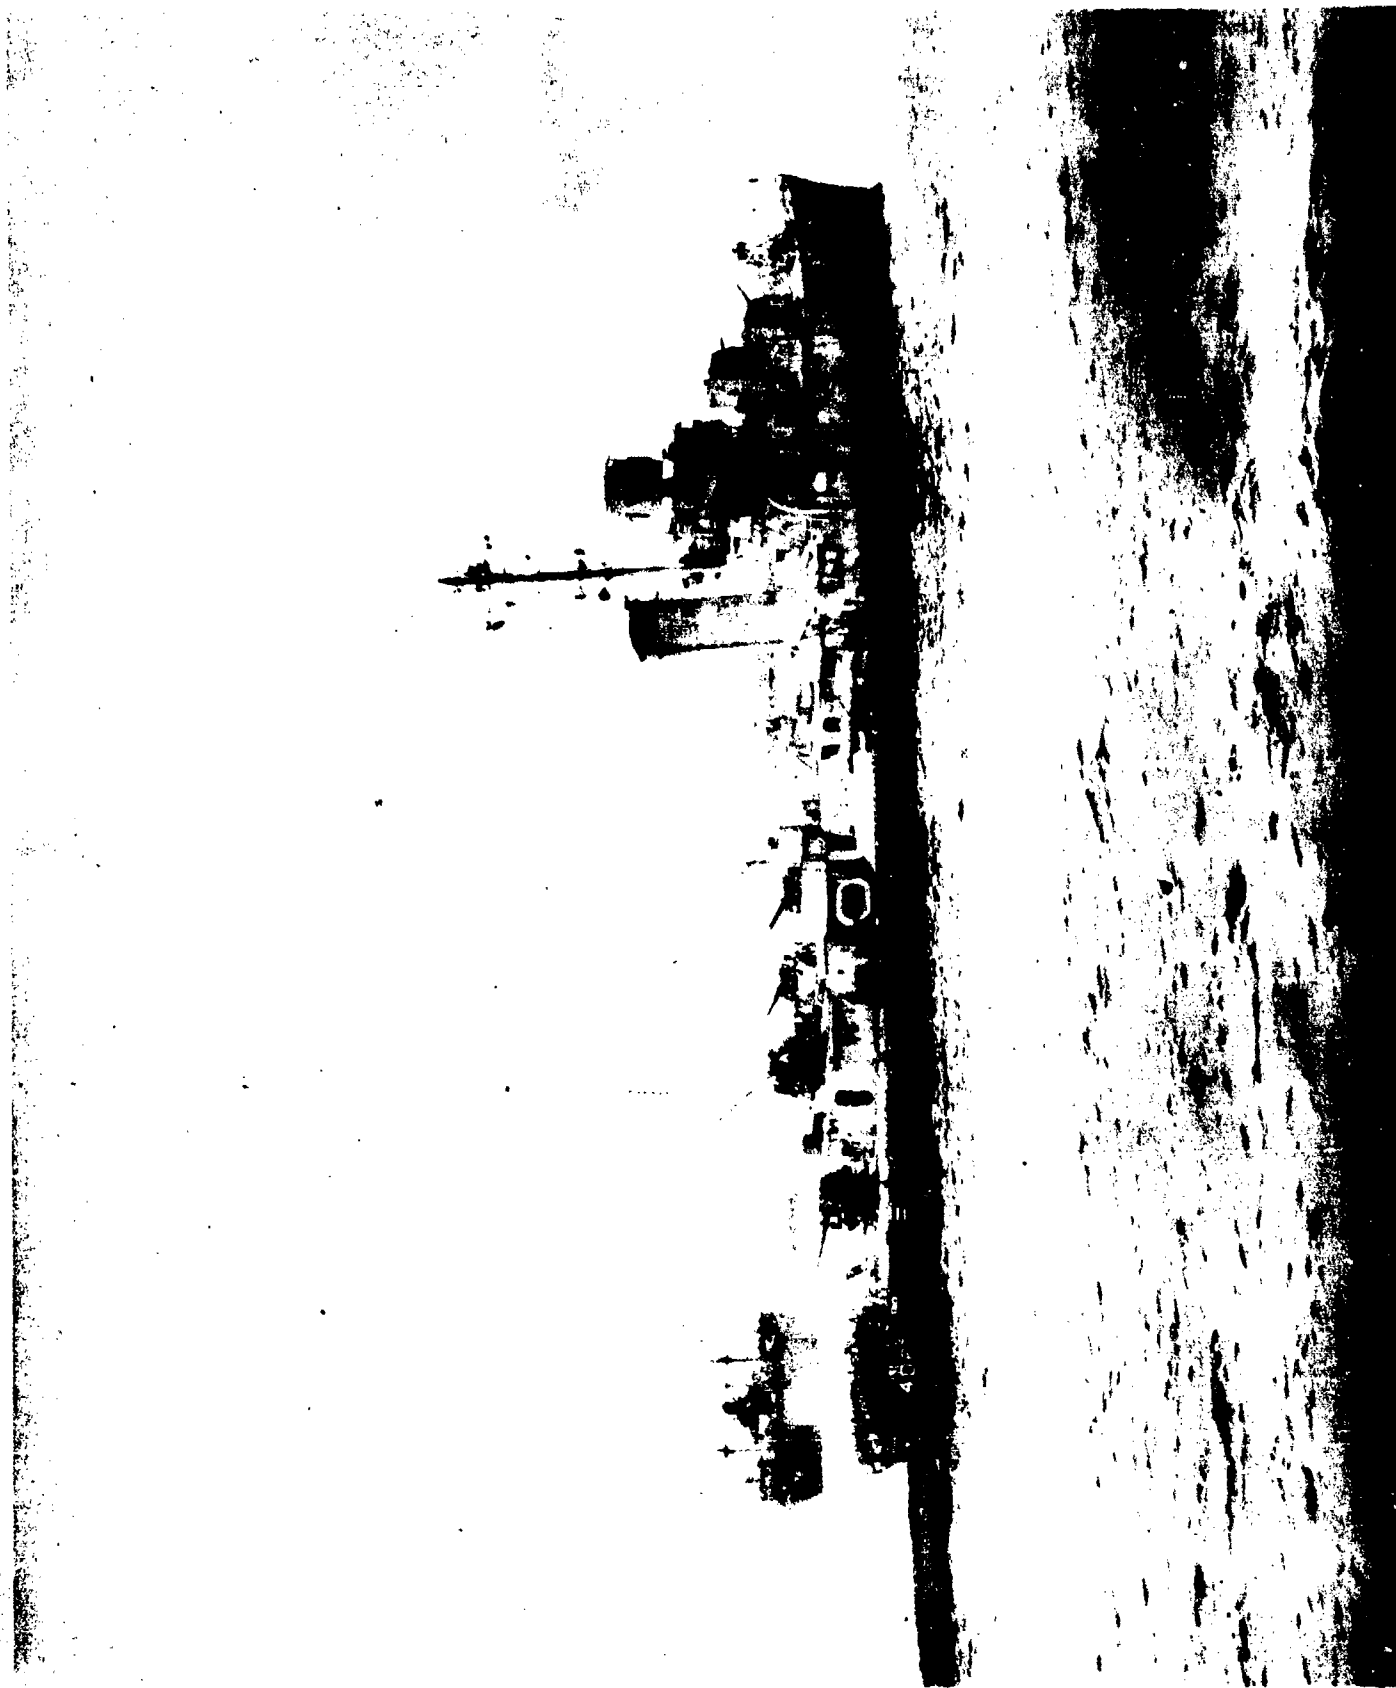
AA-CR-227-49-148. View from off starboard quarter after Test A.

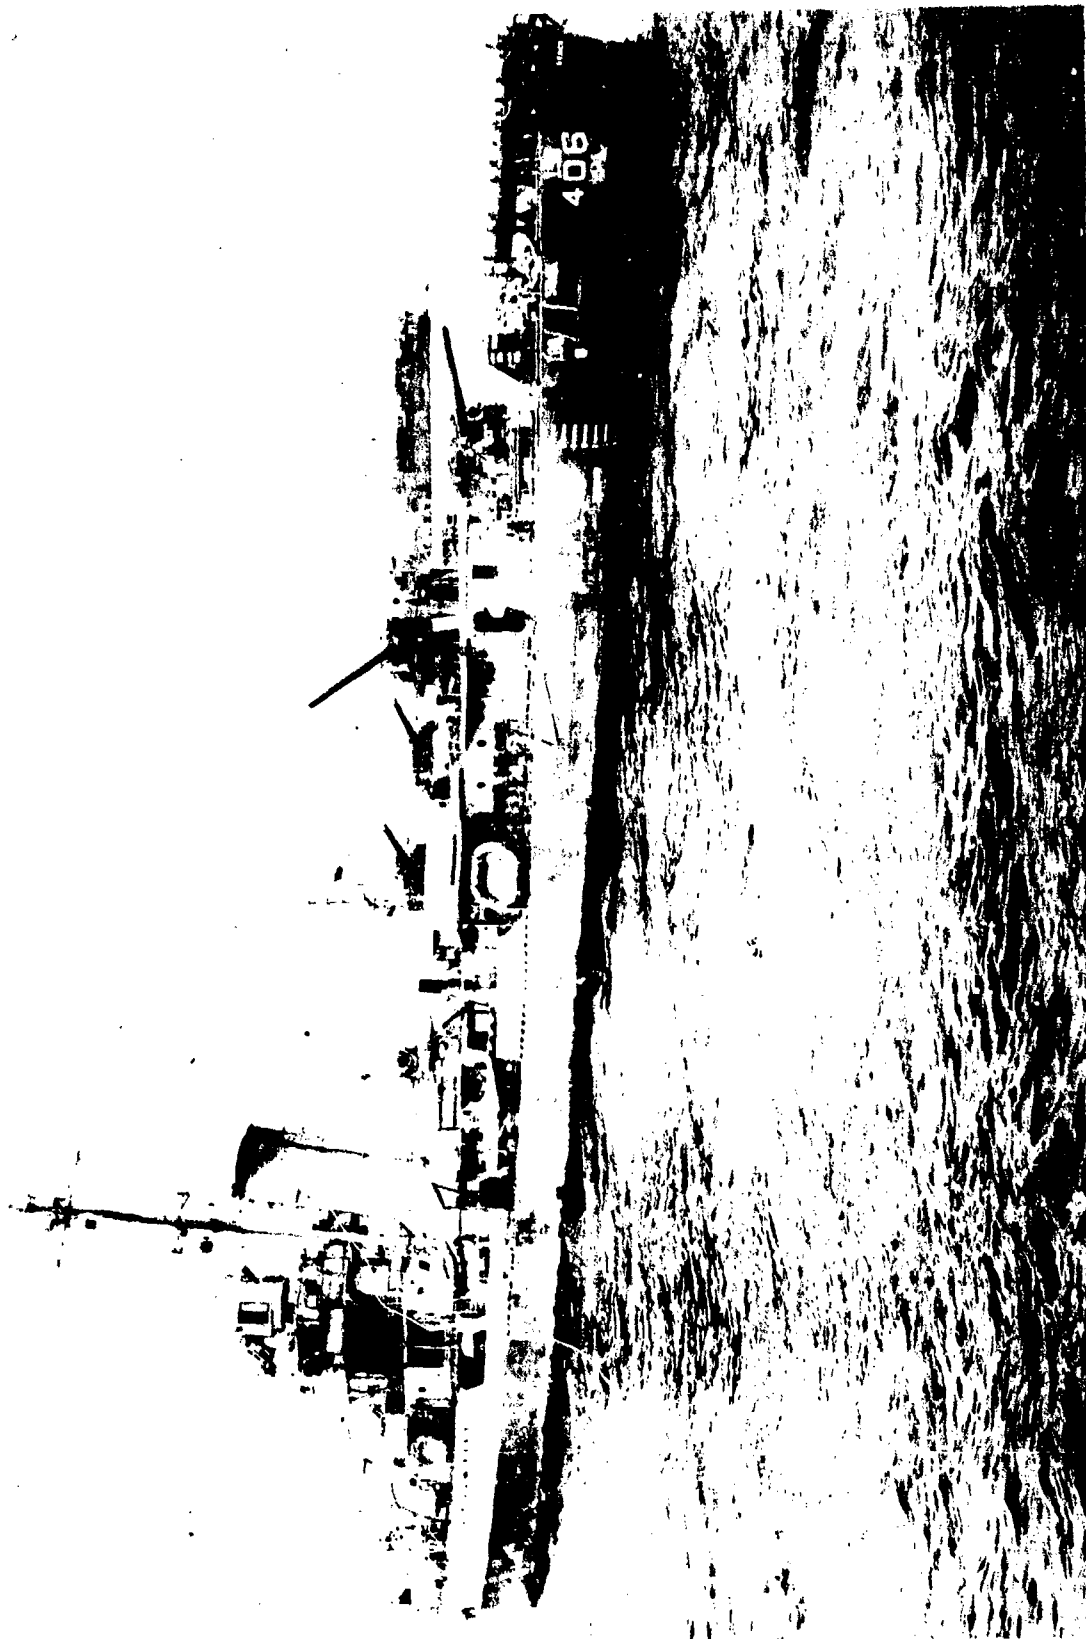
AA-CR-227-49-146. View from off starboard beam after Test A.

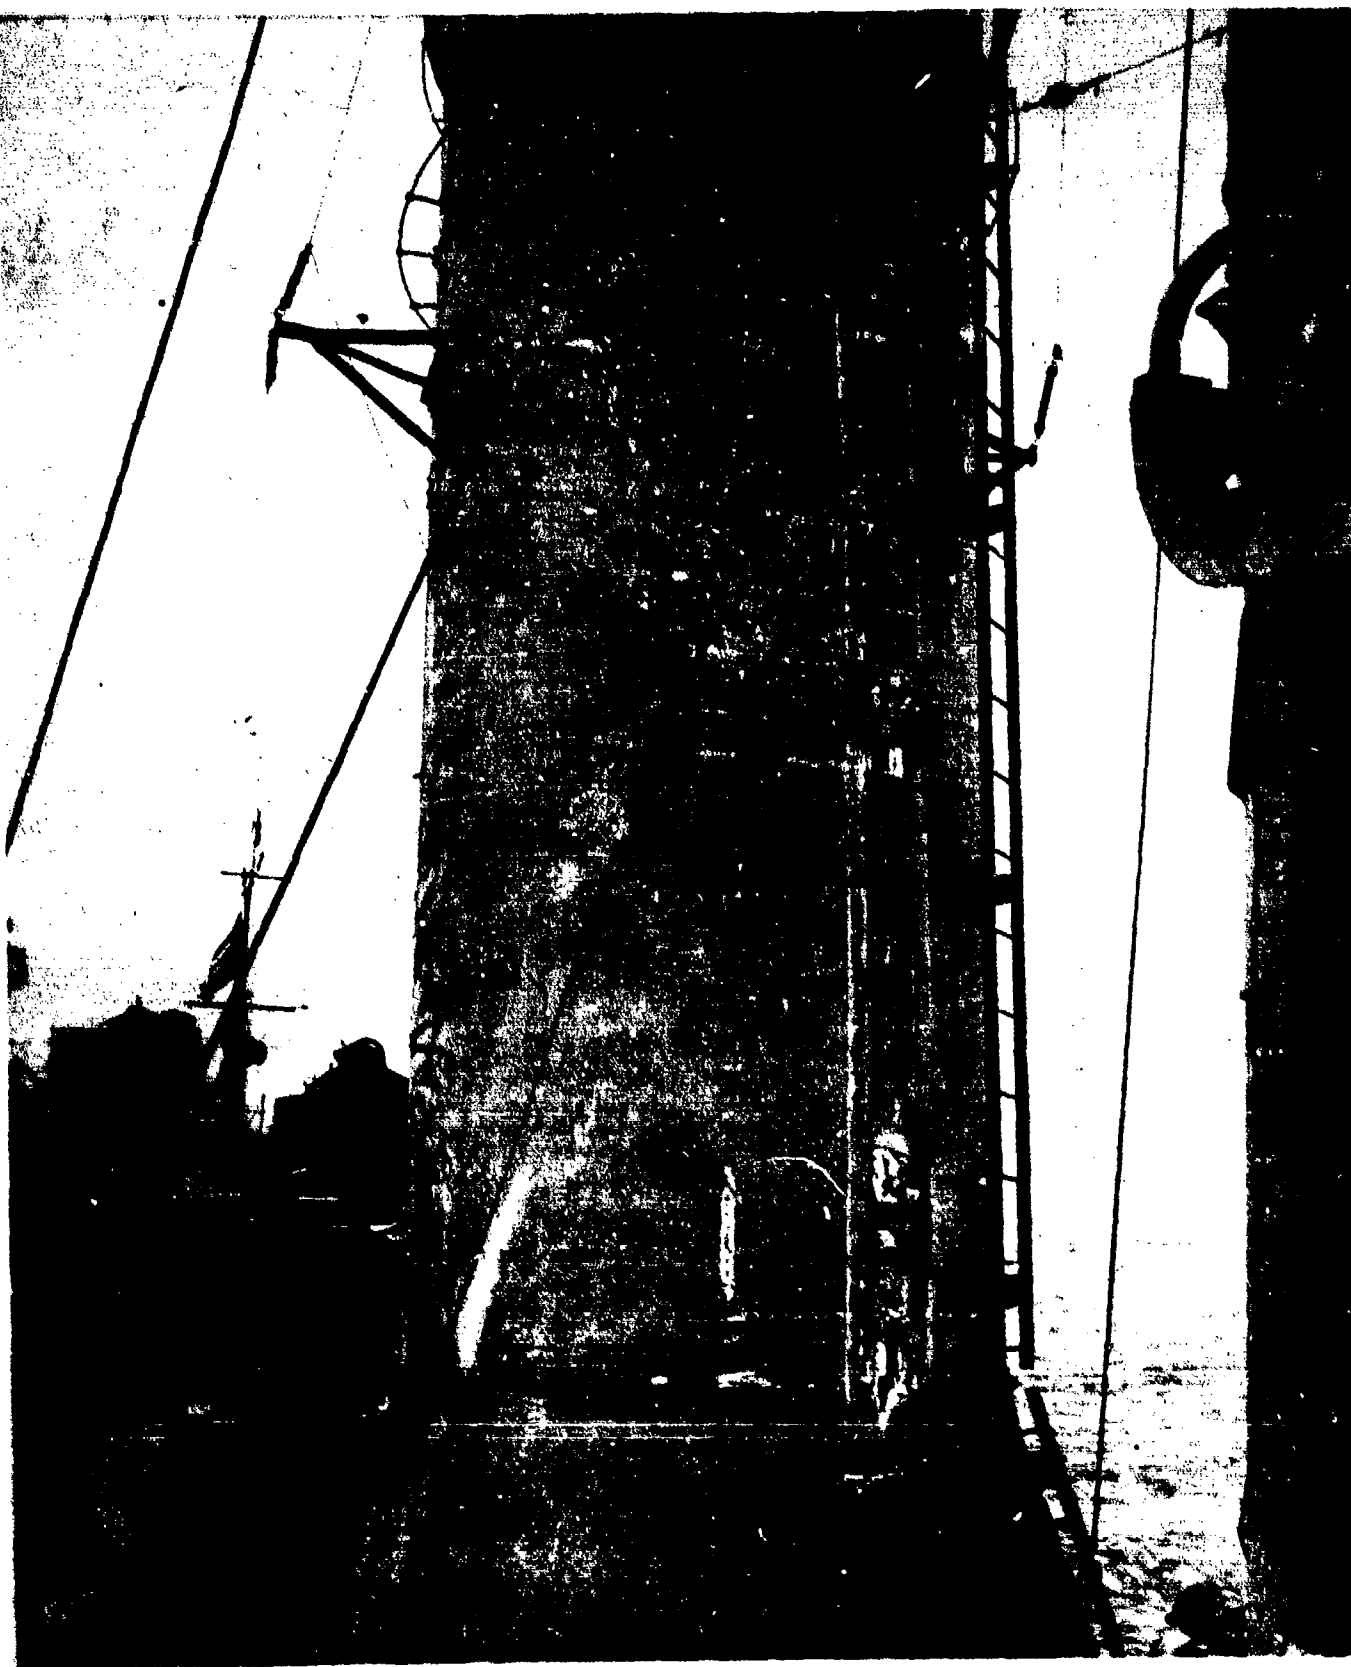
The stack is wrinkled on the starboard and forward sides, and lagging is stripped from the whistle and siren. (Photos. 1772-8, 2006-10, 1850-6; pages 54 , 55 , and 56). The stack starboard drain line is severed at an elbow. The top and starboard side of the uptake breeching are damaged. The most severe damage occurred to the forward breeching, which is severely dished and torn. (Photos. 2006-7, 2170-5,7,8,9,10; pages 57 , 58 , 59 , 60 , 61 , and 62).

AA-CR-58-2006-10. Looking aft from superstructure showing paint damage on stack and lagging stripped from whistle drain line.
